**Environmental
Hydraulics
Group**

Project: Computer Model and Tests of Pipe Leakage – Event Investigation

1990-351

Location: Chesterville, Ontario, Canada

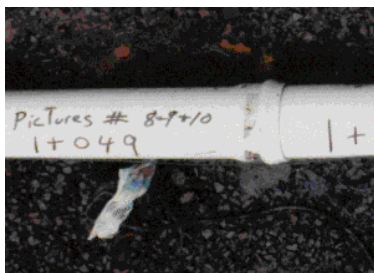
- ii) In-site investigation of a leaking pipe section revealed that a large amount of fine sand and debris had been sucked into the line as evidenced by sand jammed into pipe joints (photos a & b) and inside the pipe near the failed joints (photo c). Cracks large enough to allow such intrusion would result in significant leakage upon the resumption of pumping operations and positive pressures.

a) Excavated Pipe Section at Leakage Location

Benefits to the Client: EHG identified the cause of leaks and suggested remedial measures to protect against low pressure including: increased pump control valve closing and opening times, replacement of the upstream part of the pipeline, and installation of air vacuum and release valves at two local points and of a pressure sustaining valve at the downstream end. Leaks did not reoccur.

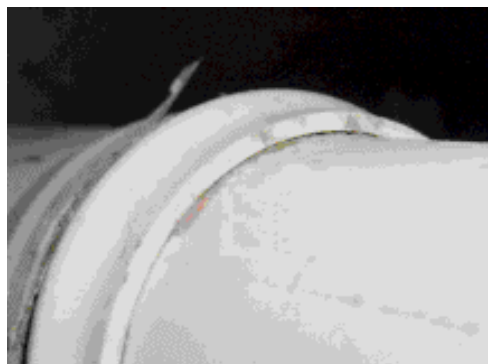
b) Pipe Joint Jammed by Sand & Dust Residue

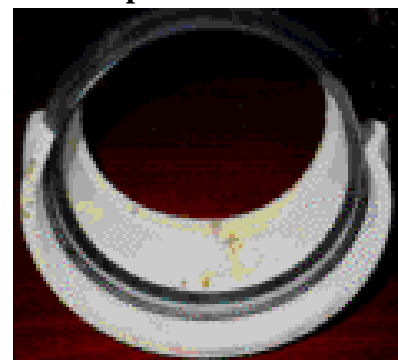
c) Sample of Failed Pipe Joint
